**HAMMAM AL ALIL DIVISION TRAINING
CENTER
MOSUL, IRAQ**

**SIGIR PA-09-174
JANUARY 7, 2010**

Summary of Report: PA-09-174

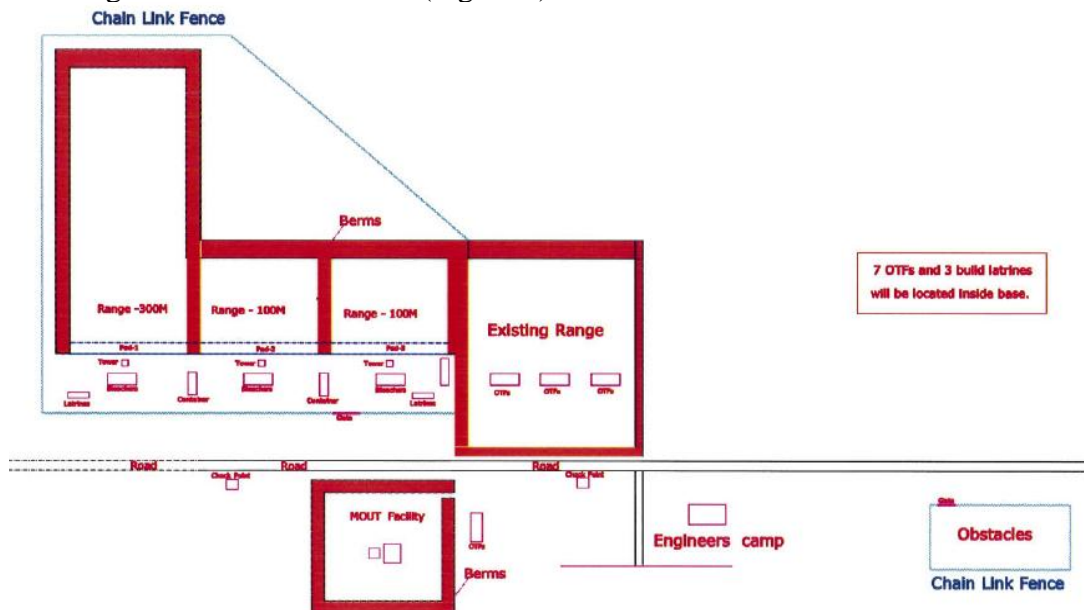
Figure 1. Proposed project site plan (Courtesy of USACE)

The SOW contained aerial views of the proposed project layout for the contractor. The contractor provided GRN with a site plan, which indicated specific locations and configuration of the facilities (Figure 1).

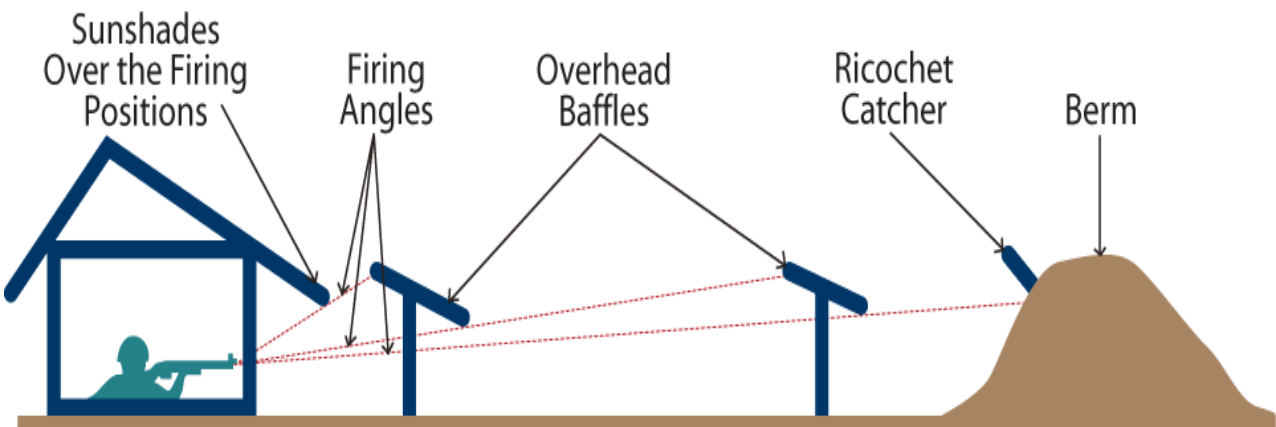
Figure 2. Multi-purpose small arms range design (Courtesy of USACE)

The SOW required that the overhead baffles be constructed between the firing positions and the ricochet catcher and berm (Figure 2) to prevent projectiles from exiting the small arms range. The SOW also required the overhead baffles and ricochet catcher to be “... *impervious to M193 ball ammo fired from an M-16, either made from 15 centimeters of 5,000 psi concrete or other material...*”. Also, the contractor was to angle the overhead baffles at least 25 degrees and construct the ricochet catcher 2m tall at a 90 degree angle to the berm with the base 6m off of the ground level.

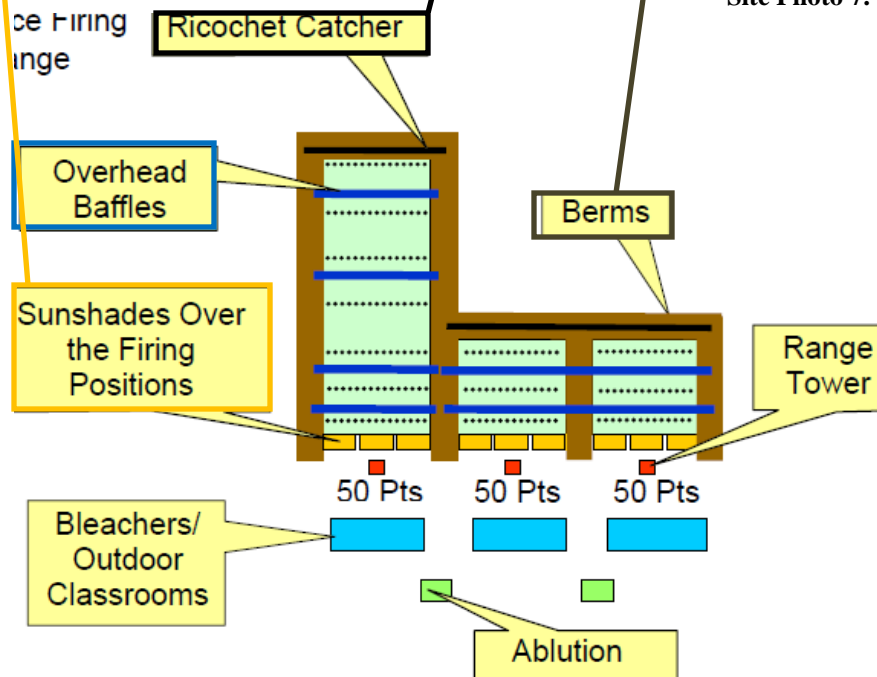
Figure 4. Multi-purpose small arms range layout (Courtesy of USACE)

The SOW required the construction and installation of overhead baffles between the firing positions and the terminal end of the range (Figure 4). Overhead baffles were designed to contain all bullets fired from a prone or kneeling position. Also, the overhead baffles were designed to contain shots that would otherwise travel over the berm.

At the time of the SIGIR site assessment; there were no overhead baffles present between the firing positions and the terminal end of the range. The GRN Mosul Area Office representative stated that the overhead baffles were constructed. However, GRN visited the site and determined that the quality of construction of the overhead baffles was extremely poor and non-compliant with the specifications as stated in the SOW. The contractor was asked to remedy the deficiencies noted for the overhead baffles. The contractor attempted to address the deficiencies, but upon further inspection of the overhead baffles, the Multi-National Security Transition Command-Iraq (MNSTC-I) made a decision to completely remove the defective work. This resulted in a descoping of the overhead baffle requirement.

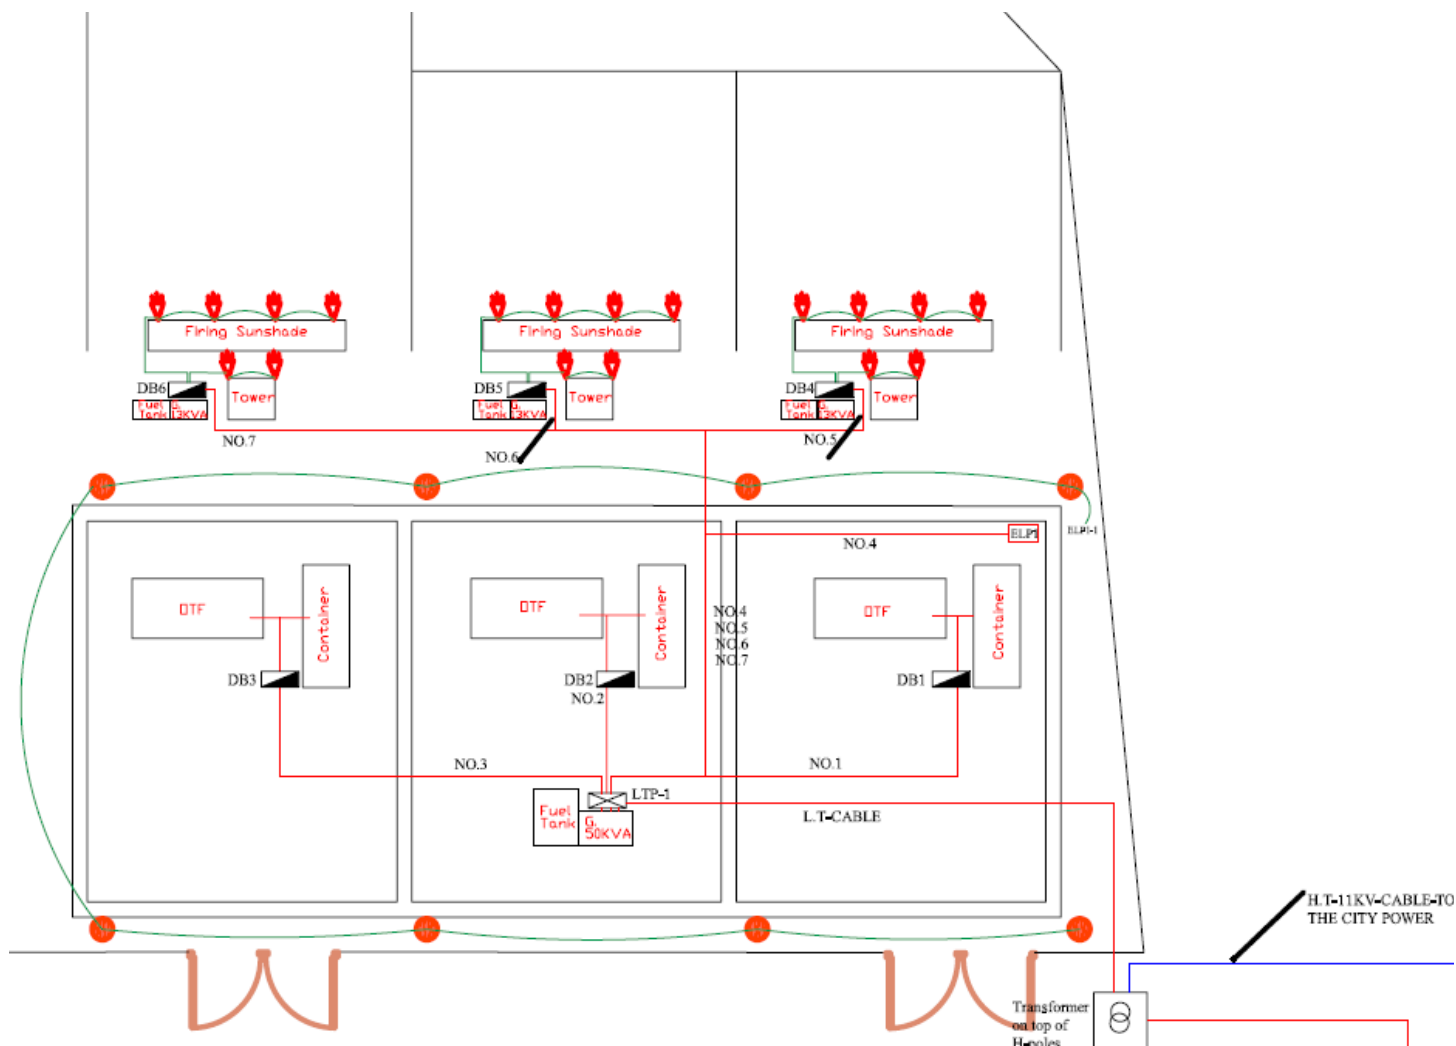
Figure 5. Multi-purpose small arms range electrical plan (Courtesy of USACE)

The electrical system for the multi-purpose small arms range consisted of a small generator, exterior fuel tank, distribution system, and exterior lighting (Figure 5). The SOW did not include requirements on the actual size or capacity of the generator. Also, the contractor did not provide calculations to determine if the generator provided meets the current and future requirements for power for the multi-purpose small arms range and MOUT facility.
